Mellor 3

Located along the grassed strip to the north of the car park, approximately 11m to the south of the Vicarage wall. With the centre of the line corresponding with a section of subsidence visible in the drystone wall.

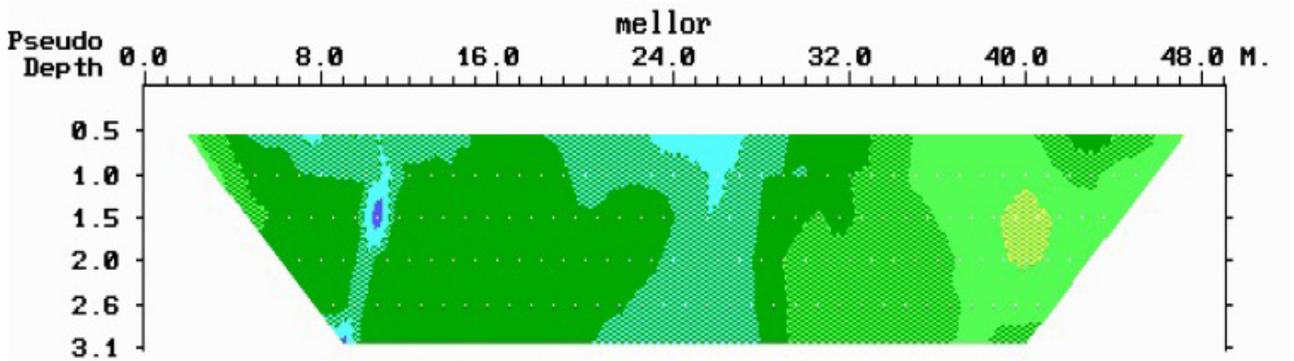
Measured Apparent Resistivity Pseudosection Unit Electrode Spacing = 1.0 M.

Anomalies at 10 ½ (off-line?), 23-27, 33, 40-47(not extending laterally?)

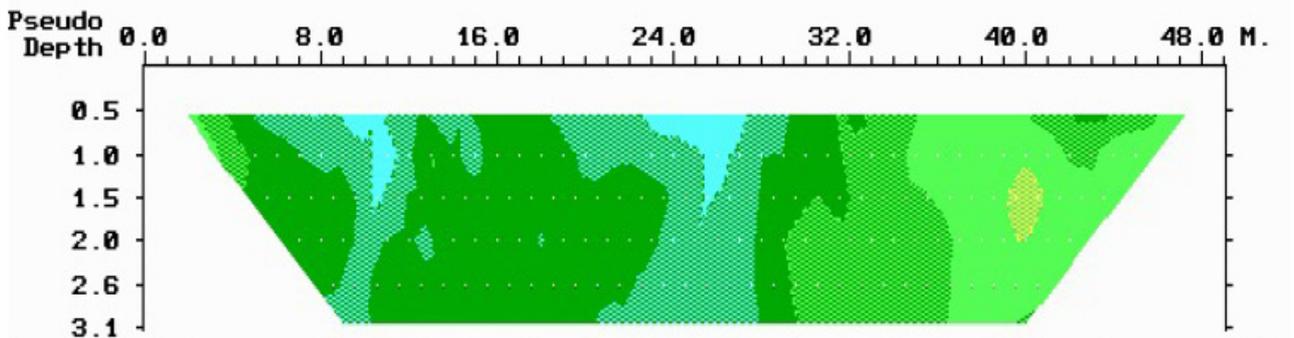
Calculated Apparent Resistivity Pseudosection Unit Electrode Spacing = 1.0 M.

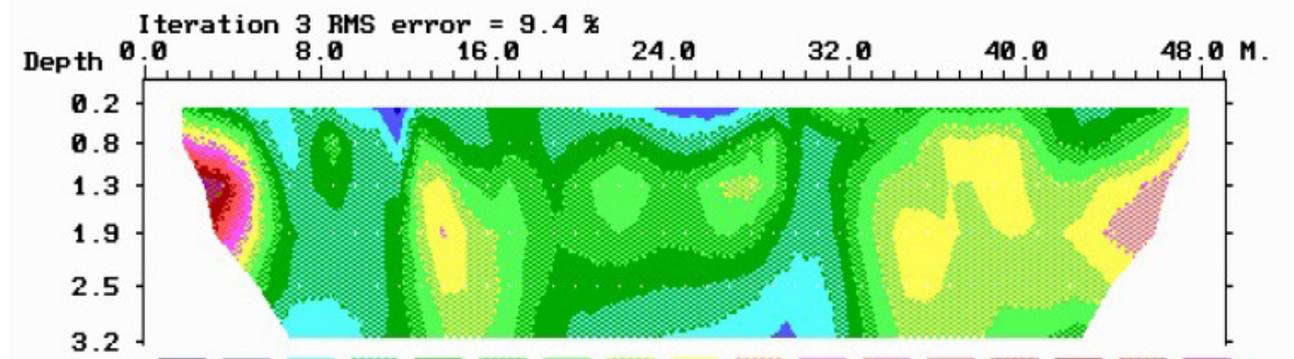
Model Resistivity Section OHM.M Unit Electrode Spacing = 1.0 M.
