Further work at the Mellor Mill Site. November, 2010.

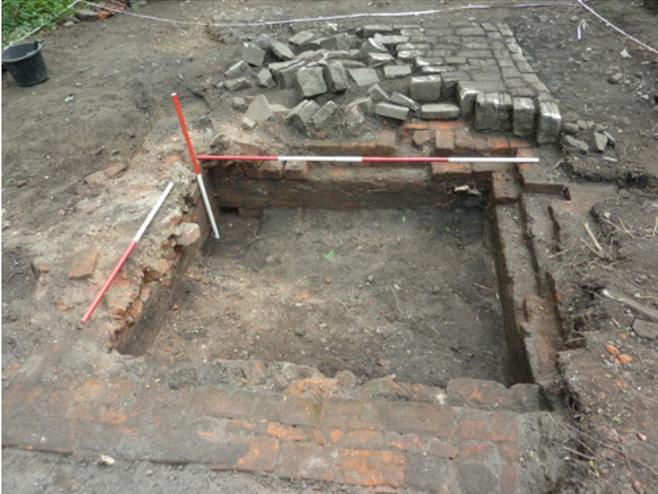
In early November a group of volunteers spent five days attempting to find some trace of the main structure of the mill at its northern end. Initial clearance of a section soon found an area of laid setts and after extending it further west it was found to partly overlay brick walling. The team concentrated on this and found a square brick structure with walls four bricks wide and a central area a little under two meters square.

Facing south. Setts and brick structure with drain.

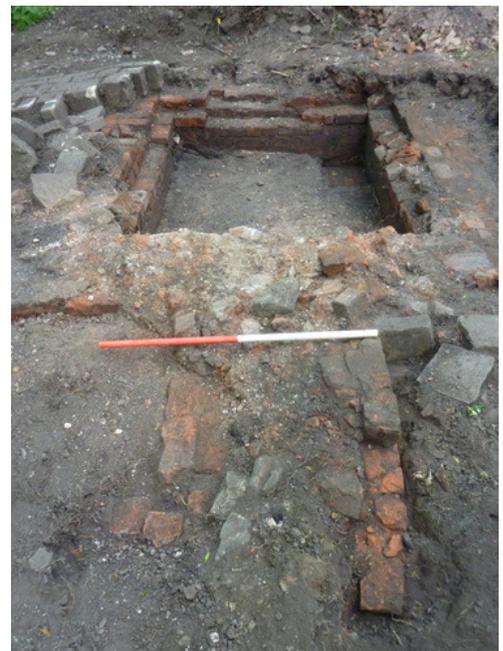
Following this down it was found to be ½ meter deep (six layers of brick) with a brick floor. A small drain was located in the southeast corner. The lower fifteen centimetres of the fill overlying this floor was primarily composed of coal dust.

North west corner and floor of brick structure

Above this was a quantity of brick rubble and it was noted that many of these bricks were curved, possibly indicating the remains of a barrel roof.

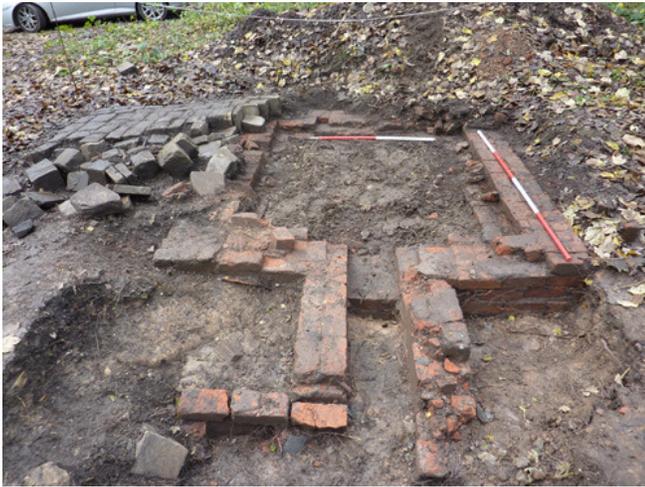
From the eastern face a further wall appeared to extend for a short distance and this was found to be a double wall with a void between them.

Facing south. Brick structure and extending walling

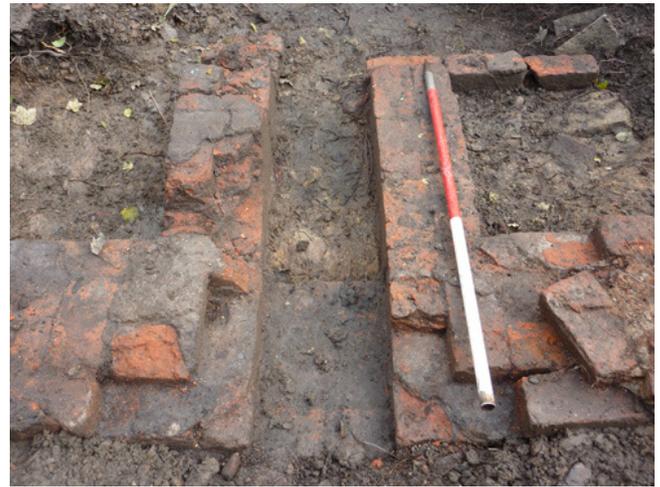
Extending walling excavated

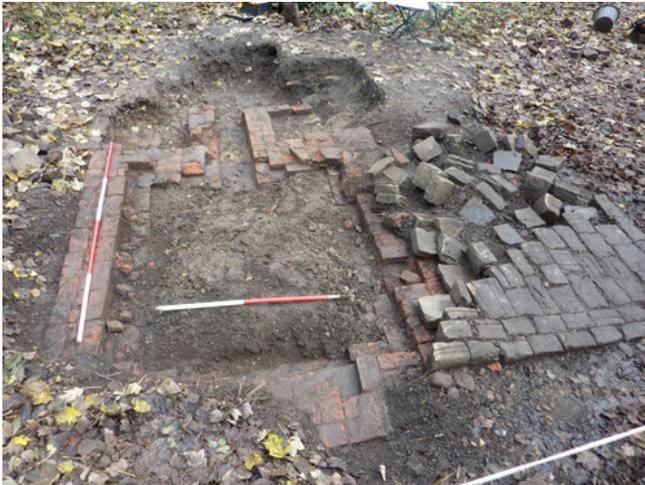
Extending walling excavated

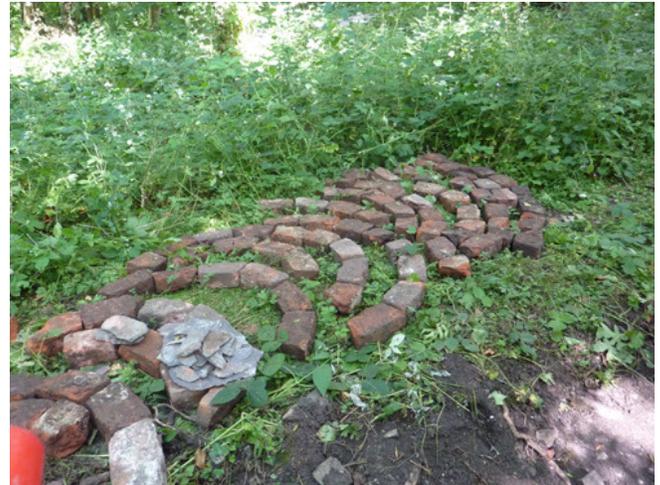
**General view with brick structure backfilled
(Facing east)**

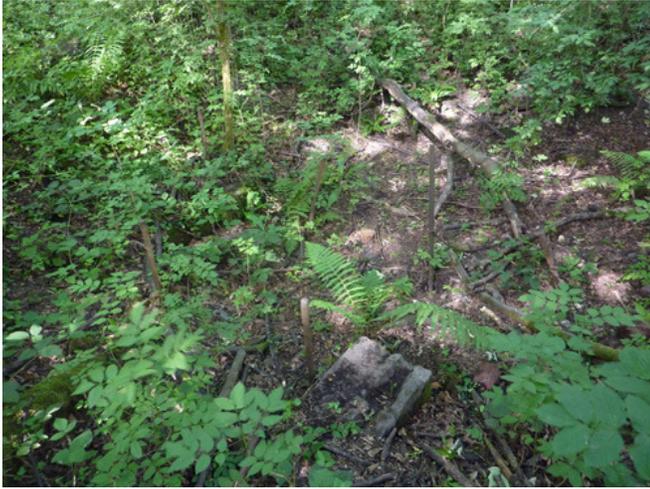
Roofing slates and curved bricks

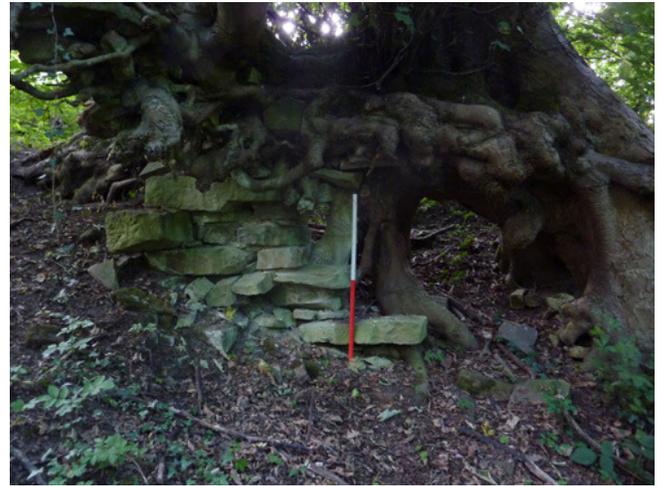
The position of this building has been identified and there are several substantial vertical steel rods and stone grooved blocks remaining in place that would have secured the engines.

**Grooved stone engine base
and steel clamping rods**

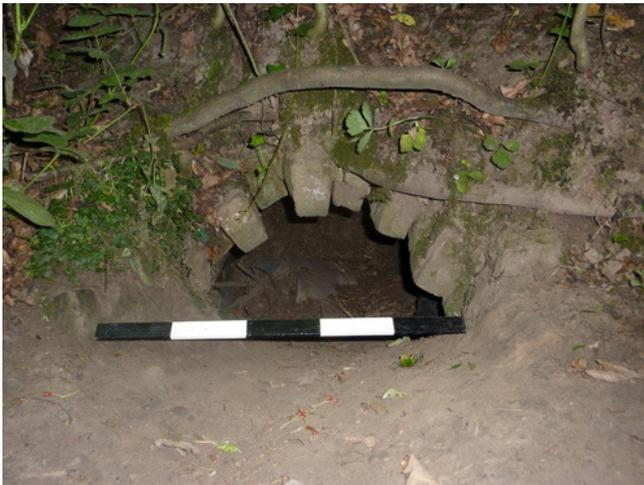
There are also the remains of stone walling at the rear now overgrown by a large sycamore tree, and behind that the almost buried entrance to the flue that carried the smoke from the furnace to the chimney, which was situated some distance up the hillside

Wall remains at rear of engine house

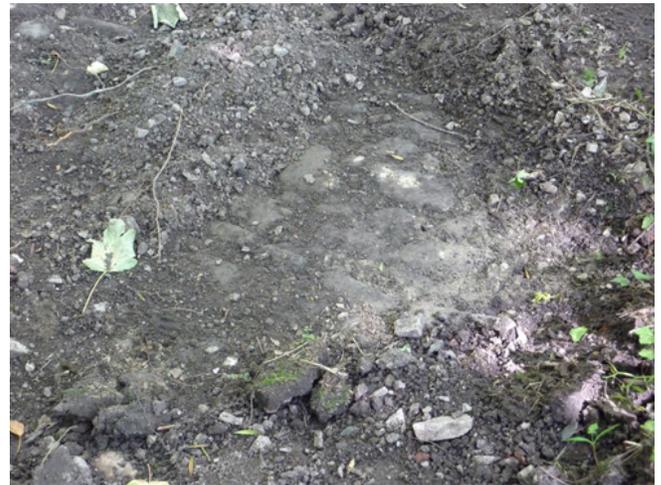
Flue to chimney
